DOT/FAA/AR-98/22

FAA T53-L-13L Turbine Fragment Containment Test

June 1998

Final Report

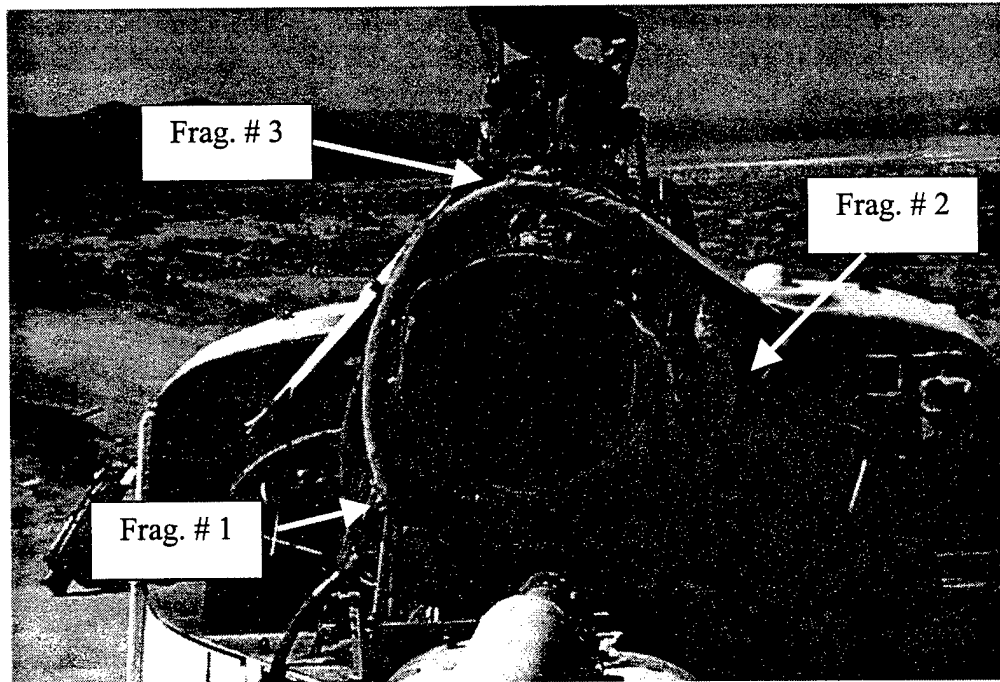
Figure 8. Posttest Engine

The test was completed as planned. The cameras were triggered as Np passed through 14,000 rpm. The disk released at 19,629 rpm. Test data are provided in figures 5 through 7. The disk ruptured into three nearly equal sections that were contained by the containment ring. The outer titanium shell split due to the tensile load resulting from the disk fragments pulling the Kevlar into a triangular shape. All three disk fragments penetrated the engine combustor case. The fuel lines located between the containment ring and combustor case were penetrated, resulting in a small fire. Secondary blade fragments exited the engine exhaust nozzle and a few fragments

appeared to exit through the holes created by the disk fragments. These fragments were low-energy releases. Post event pictures are provided in figures 8 through 11.

The engine stayed within its mounts, with little apparent duress caused from the disk fragment energy being absorbed. The only noticeable sign of high vibration or loading was a broken throttle linkage.
